December 1976

THREE RIVERS, OTERO COUNTY, NEW MEXICO

A PROJECT OF EXCAVATION, STABILIZATION, AND
INTERPRETATION OF A PREHISTORIC VILLAGE

A REPORT PREPARED FOR THE U.S. DEPARTMENT OF THE INTERIOR, BUREAU
OF LAND MANAGEMENT, LAS CRUCES DISTRICT, by the Cultural Resources
Management Division of the Department of Sociology and Anthropology,
New Mexico State University, Las Cruces, New Mexico.

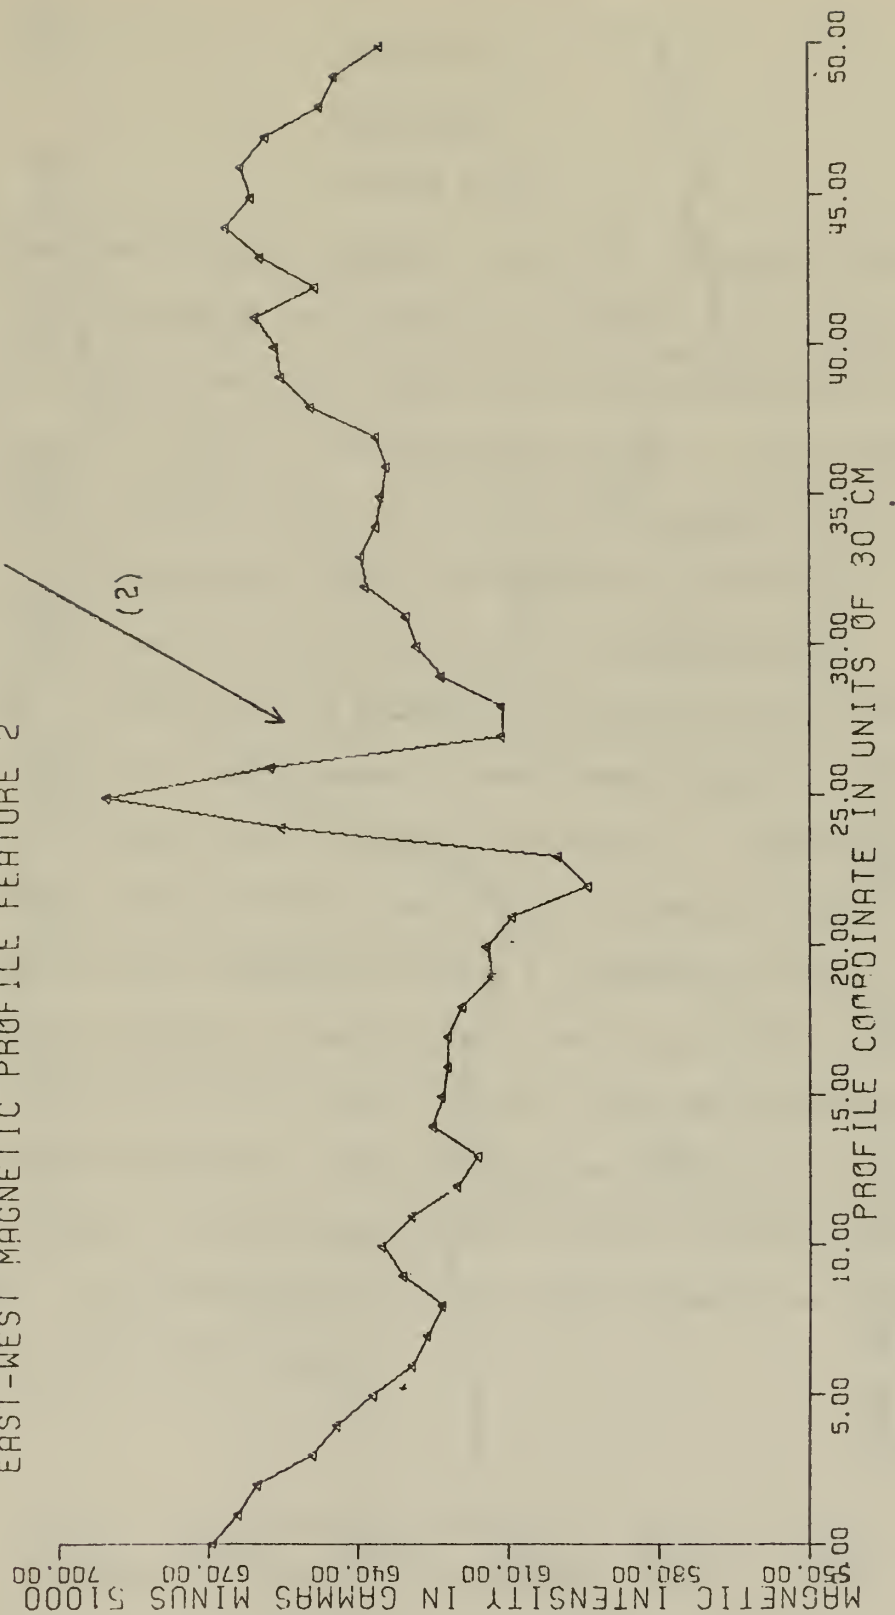
ILLUSTRATION 27
EAST-WEST MAGNETIC PROFILE FEATURE 2

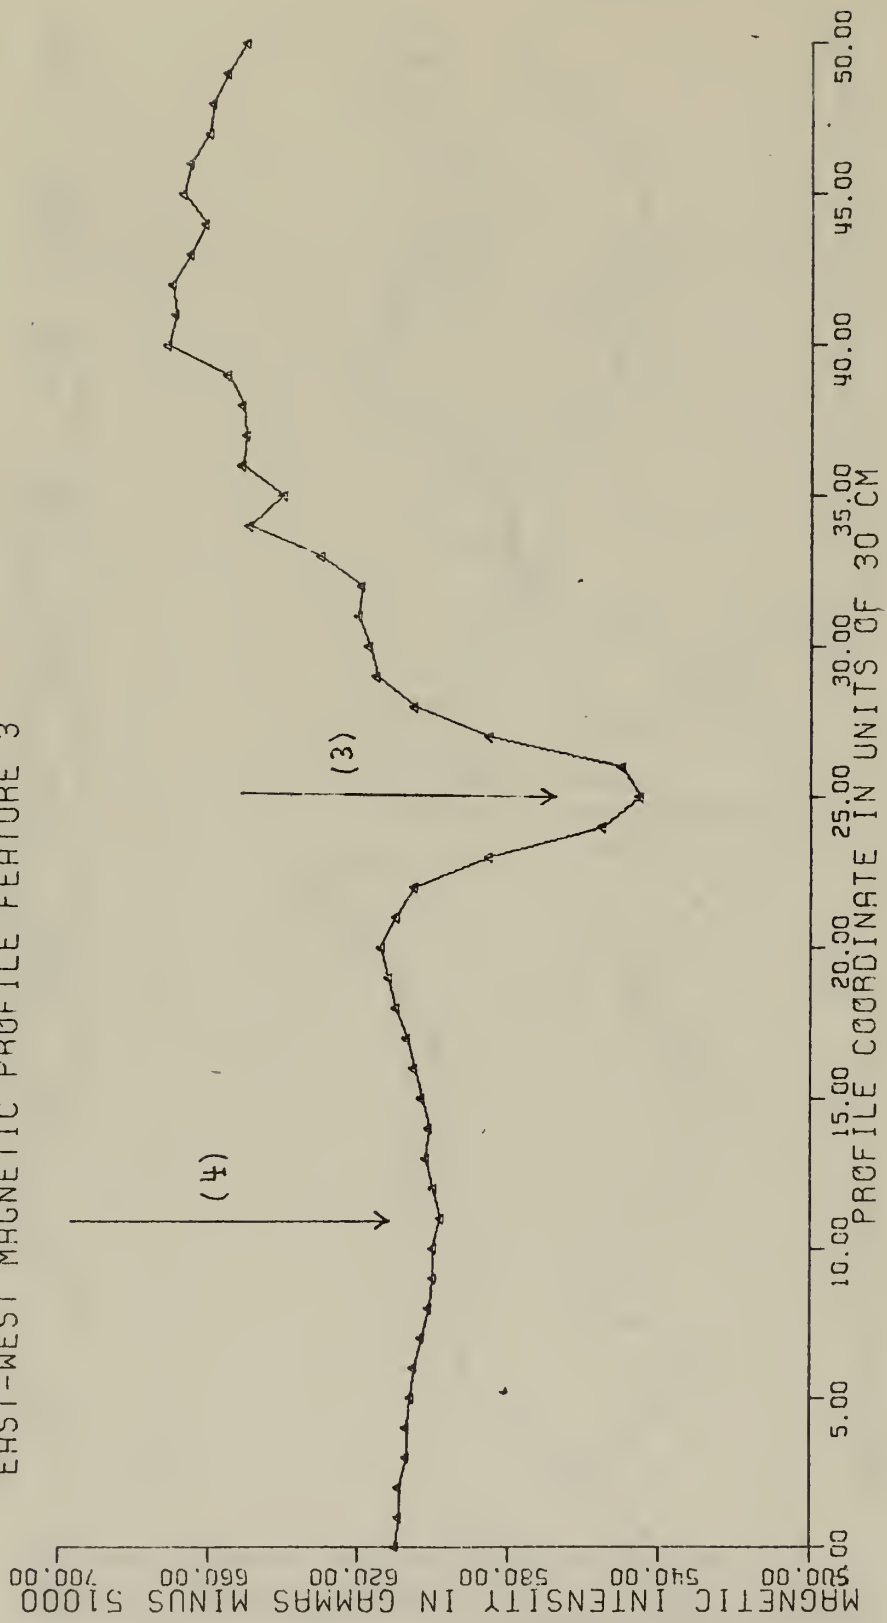
ILLUSTRATION 28
EAST-WEST MAGNETIC PROFILE FEATURE 3
